Preventing cold storage condensation

Claus Sørensen A/S, Denmark

Case study:

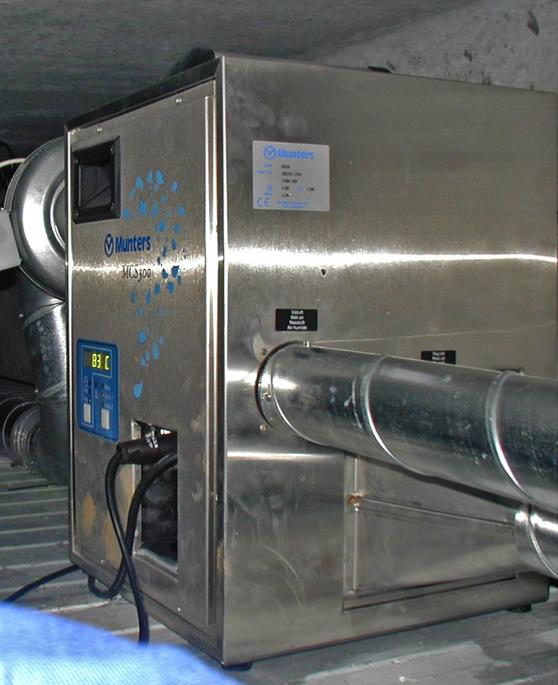
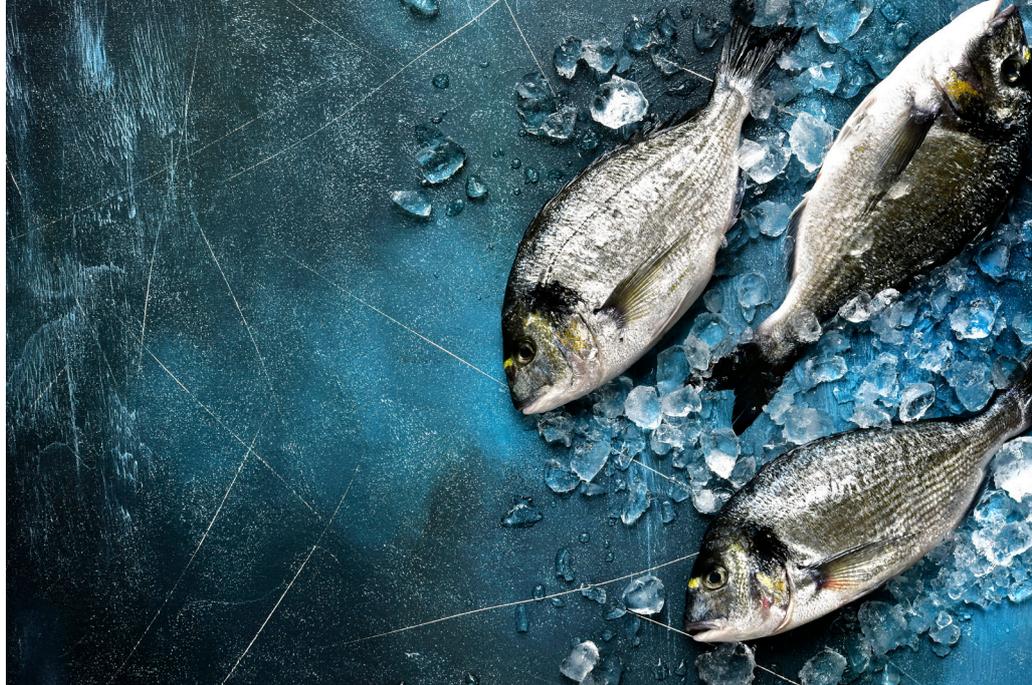
After an inspection of the facility, Munters developed a solution proposal that the company immediately chose to implement. Two small dehumidifiers were installed on the ceiling, and these now ensure a stable, low humidity that prevents the formation of condensation.
