Improved ice quality and climate with Munters dehumidification Leuven Ice Rink, Belgium

Munters dehumidification improves Leuven Ice Rink

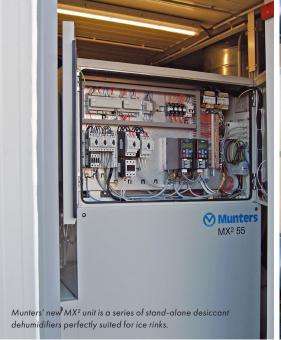
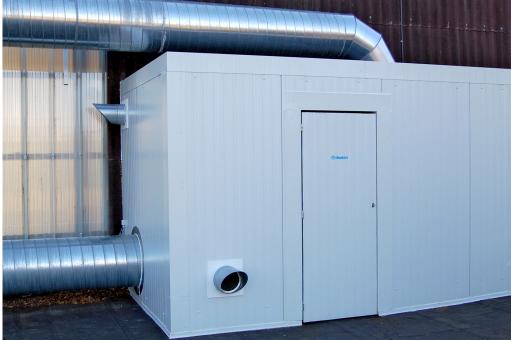
Munters MX² series

The MX^2 series is an updated series of desiccant dehumidifiers, based on the existing MX-range, widely known and acknowledged as a true work horse, creating the optimal climate in a variety of applications.

The MX and now MX^2 series control the indoor humidity condition in ice rinks, ensuring that condensation will not occur. By keeping the relative humidity low, below about 55% RH year-round, the ice rink will run smoother and be energy efficient.
